Project No.
17373.000.002

Subject: Embankment Repair near 2121 Alameda Diablo Avenue
Diablo, California

SOIL DESIGN PARAMETERS FOR PERMANENT EMBANKMENT REPAIR

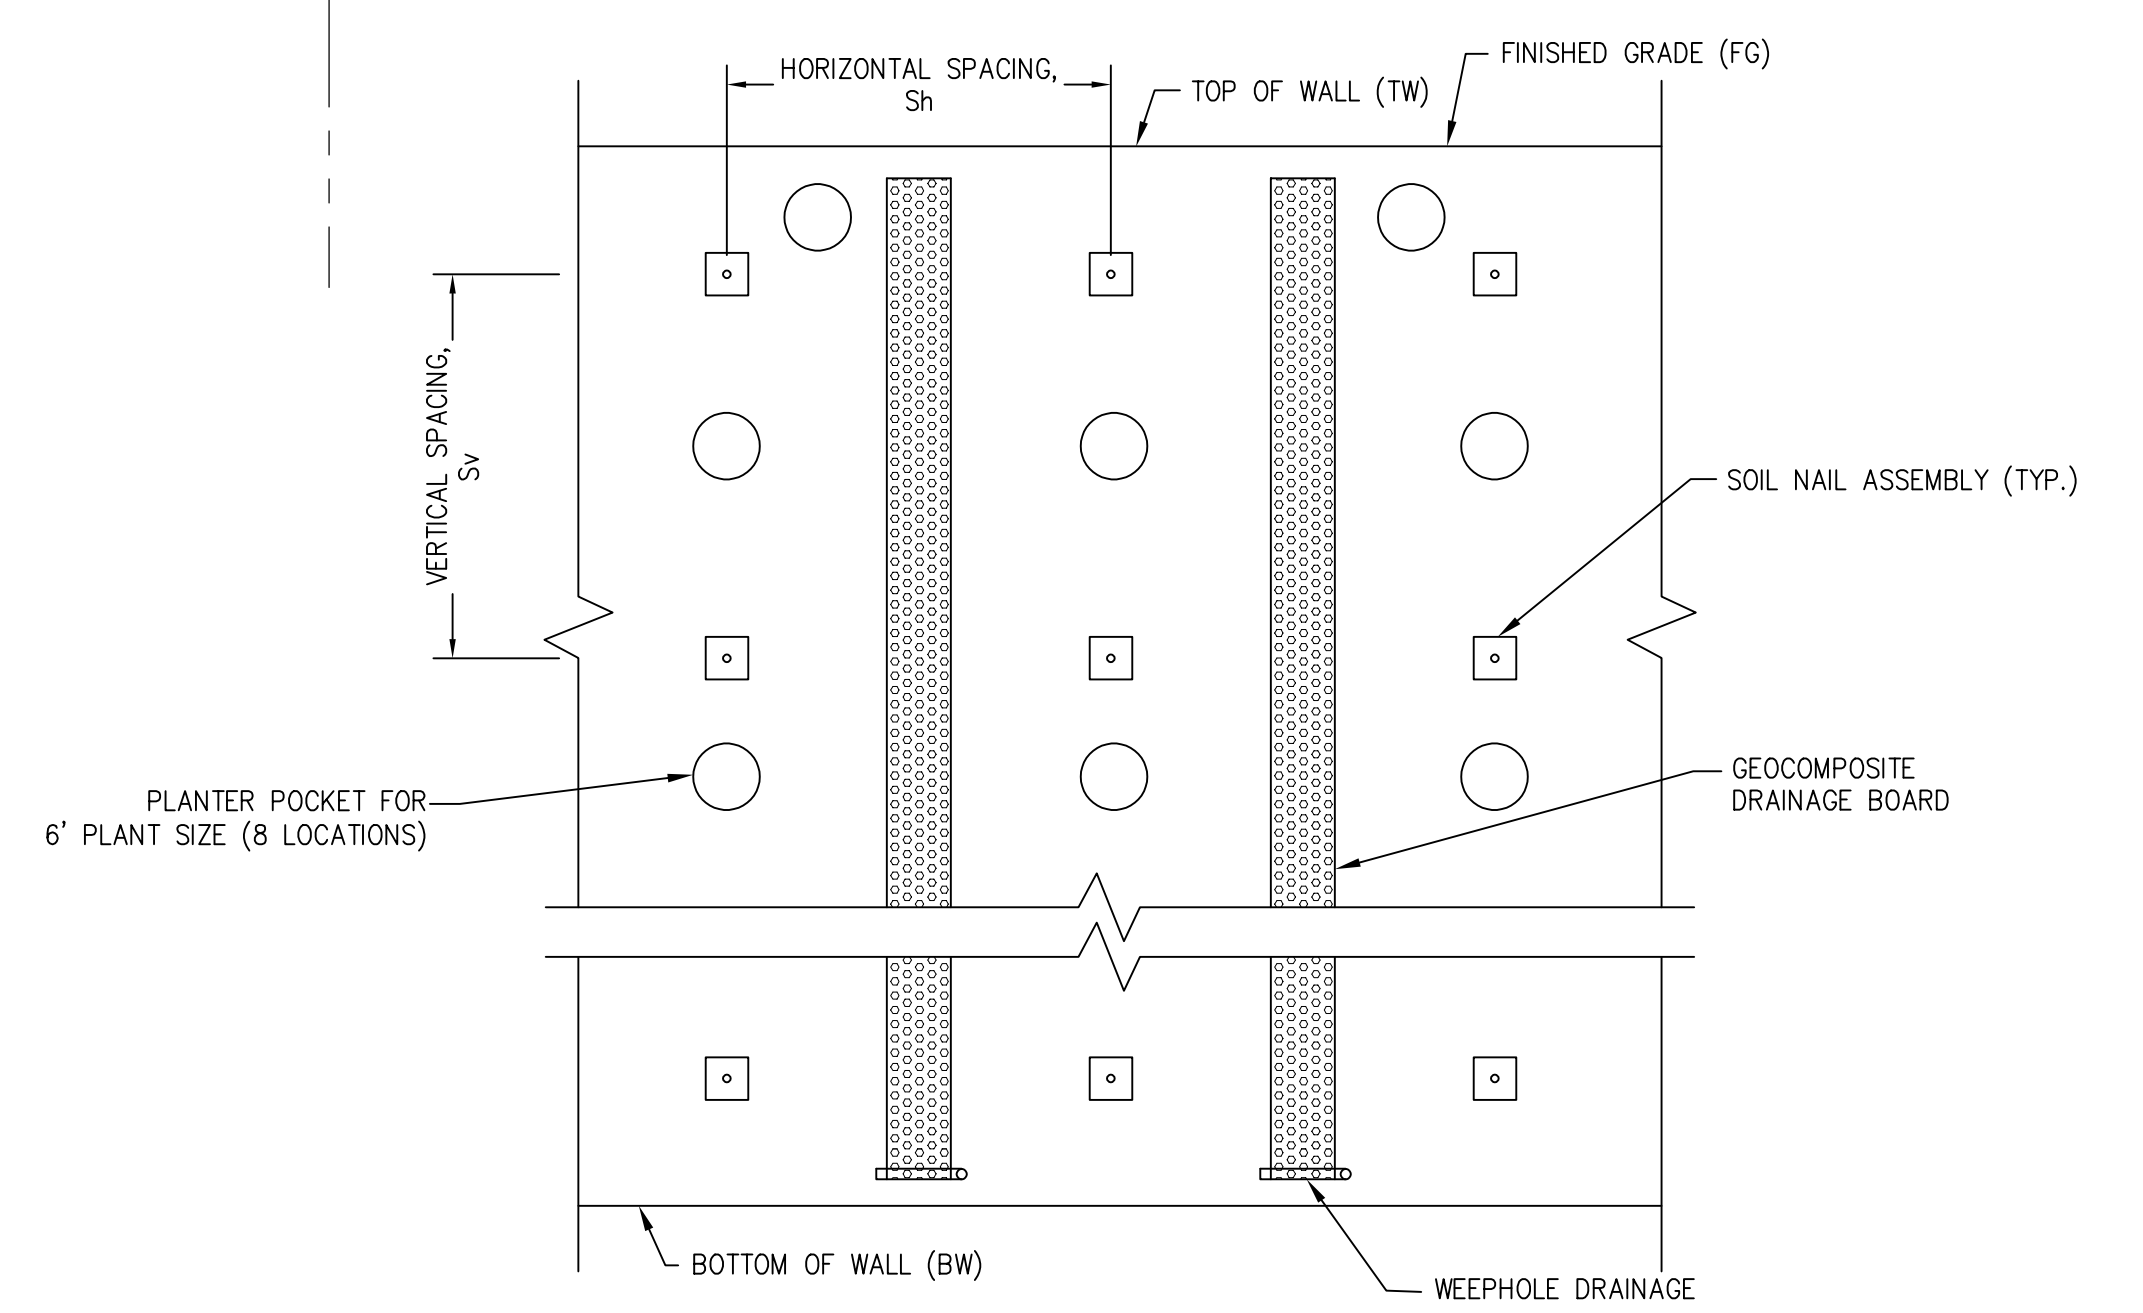
3 PARTIAL ELEVATION
NO SCALE

- NOTE:**
- REINFORCEMENT NOT SHOWN FOR CLARITY
 - SOIL NAIL SPACING AND LAYOUT PER CONTRACTOR DESIGN
